lot 5
Recommendations that would protect the salmon.

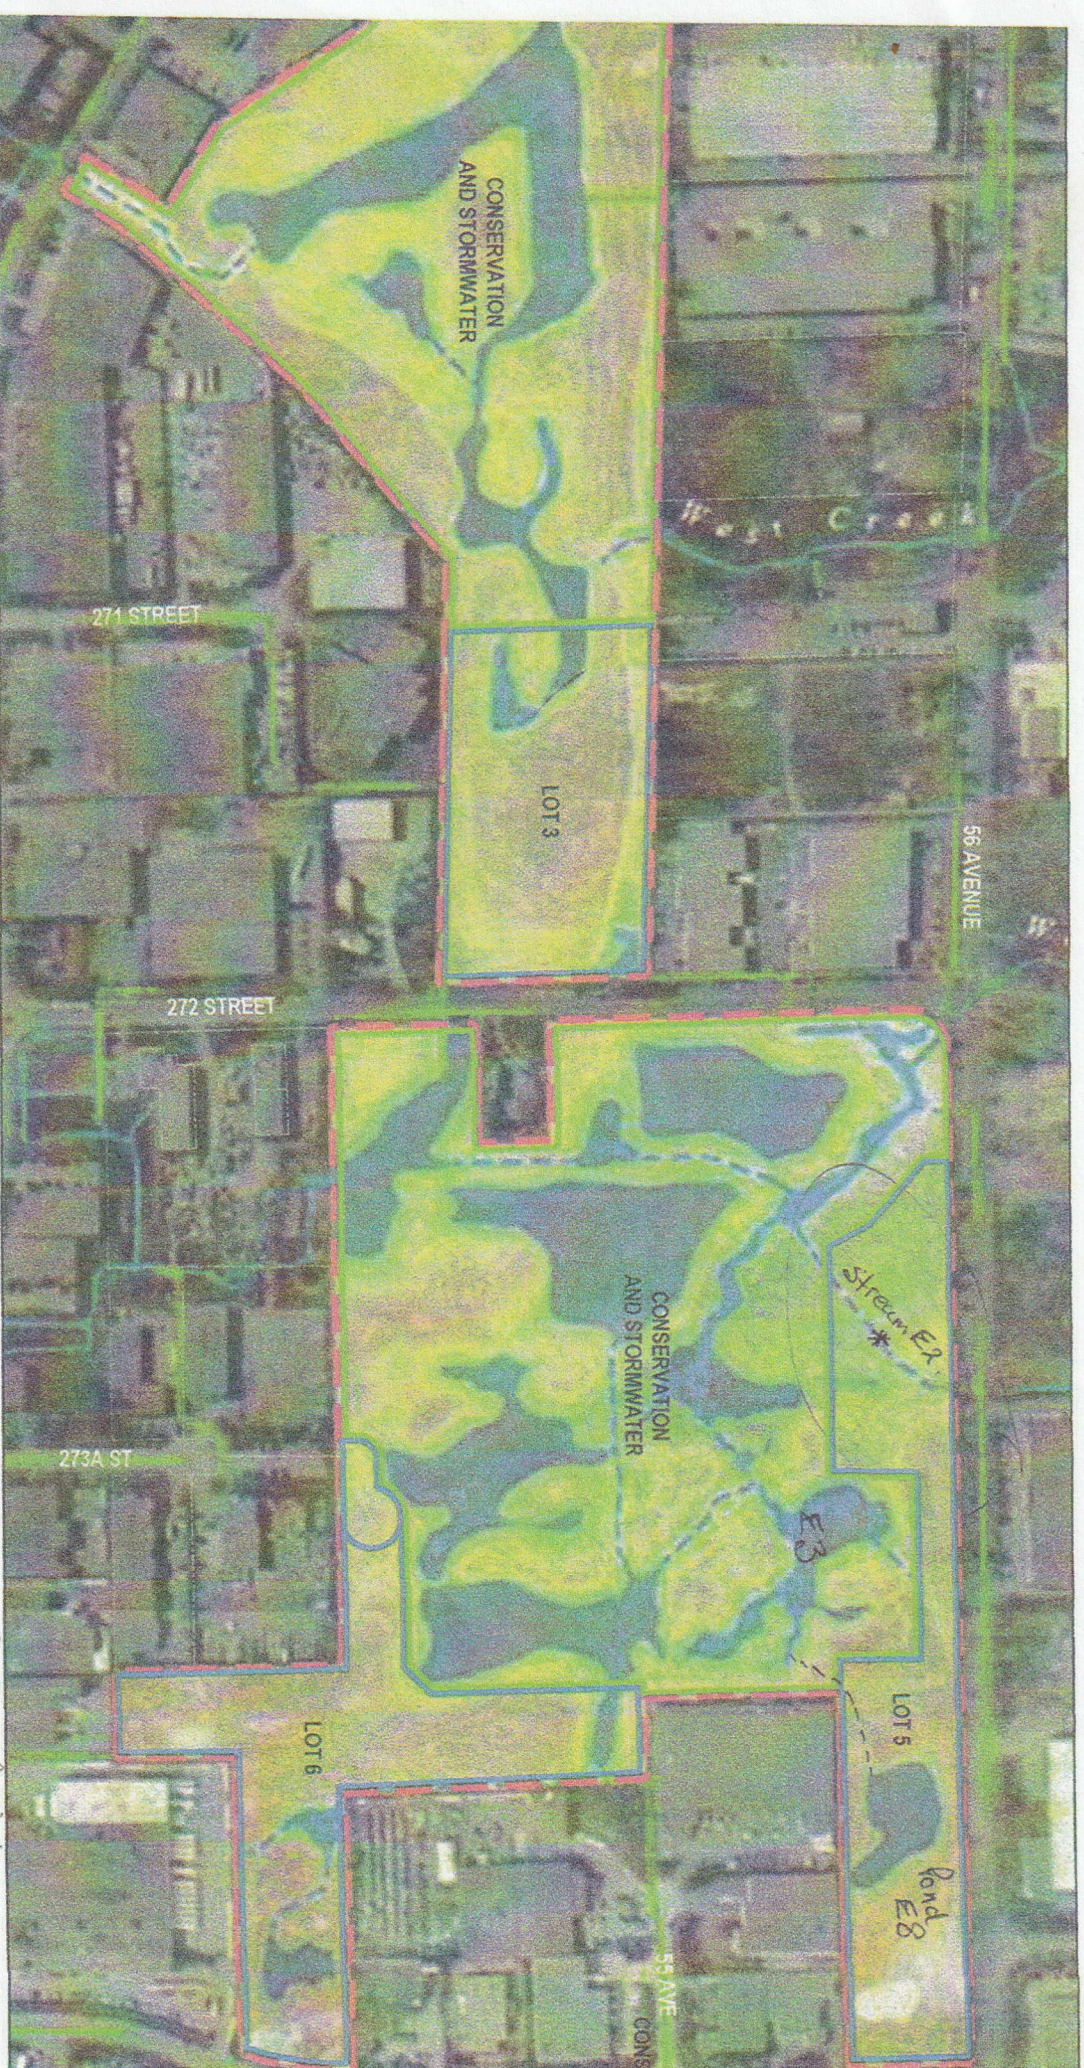
- Lot 5:
- ① Salmon have spawned in Stream E2 (point marked *) but are blocked from going further North by a gravel plug. This spawning channel could and should be restored.
 - ② Glacial pond E8 is full year round and was cut off from E3 by the building on the corner. This cut-off causes flooding issues which could be resolved by reconnecting Pond E8 to E3.
 - ③ We respectfully ask that Lot 5 NOT be industrialized and that the streams be restored for spawning salmon!
